Low Water Pressure Issue

Rev 1.3 Oct 2013

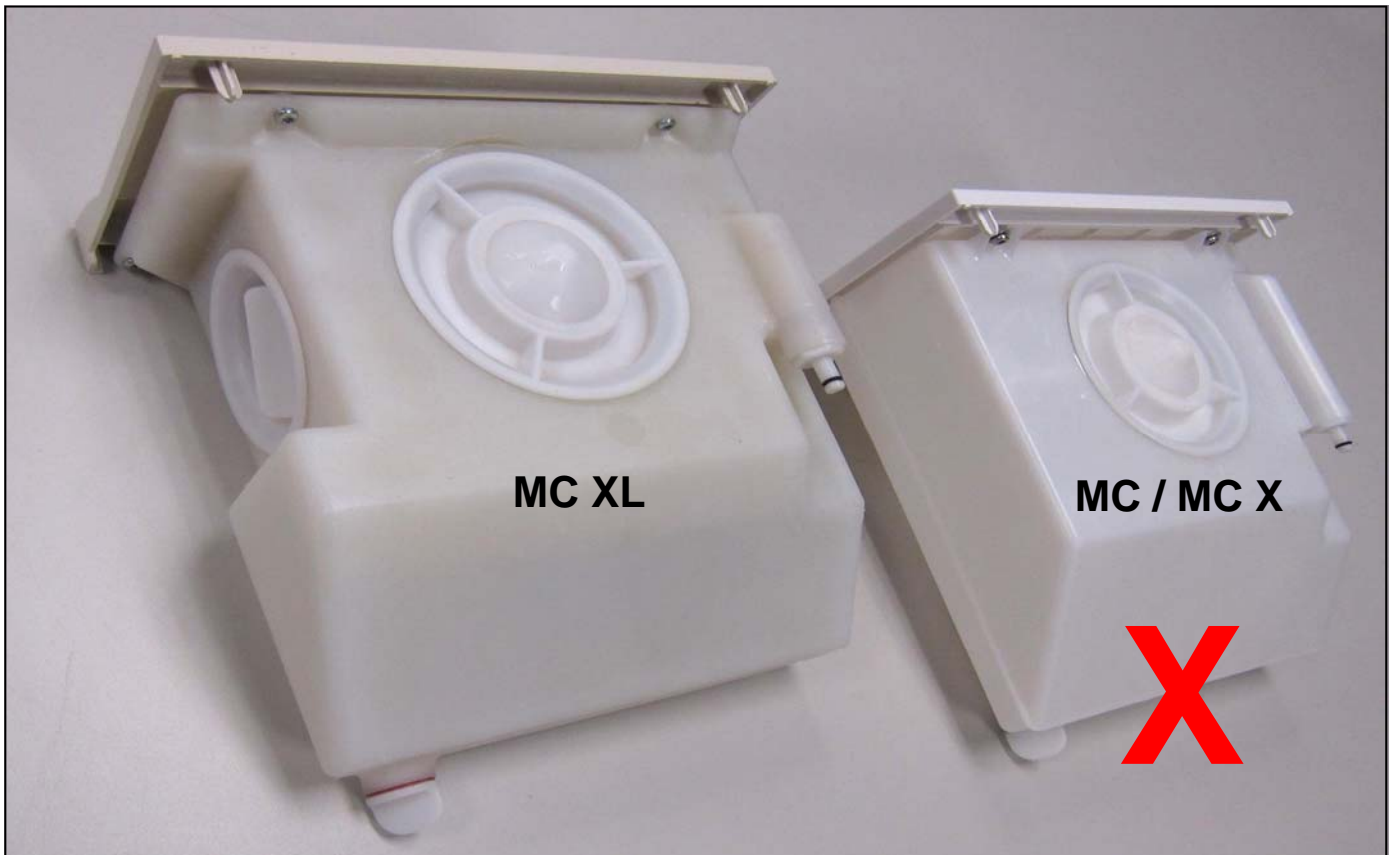
MC XL Water Tank P/N

SIRONA DENTAL Inc. is investigating reports of low water pressure issues with CEREC MC and CEREC MC X milling units. Our current solution to this problem is to equip all CEREC MC and MC X units with CEREC MC XL water tanks (horizontal water filter).

Use replacement water filter P/N 6129519 for these MC XL tanks as the original filter for the MC /MC X will not work.
